**Flood Control Project Maintenance
Levee Inspections
LMA District Cover Sheet
Spring 2010 Levee Inspection Results**

Levee District No. 0002 (Glenn County)

Levee Inspection Report By Mile - Spring 2010

Waterway						Bank	Unit Miles	Inspection Start/End	Inspector	
Unit No. 01 Glenn County Sacramento River						Right	4.89	03/26/2010 03/26/2010	Bob Duffey

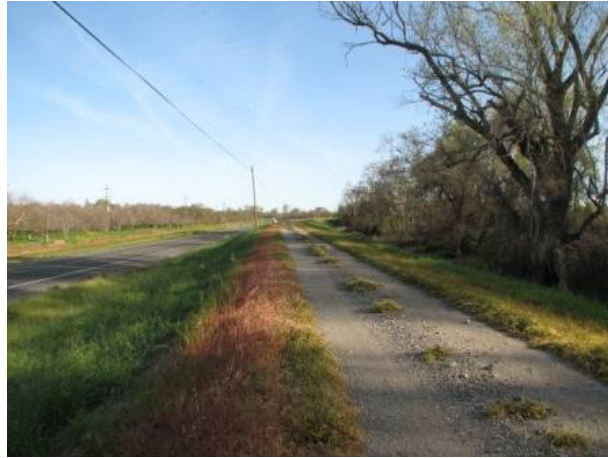
rduffey_s_20100607_001.jpg

Levee Mile Report Line	1
Start Levee Mile	0.66
End Levee Mile	0.80
Location	Water Side
Category	Earthen Levee
Item	Vegetation

typical view of the levee.

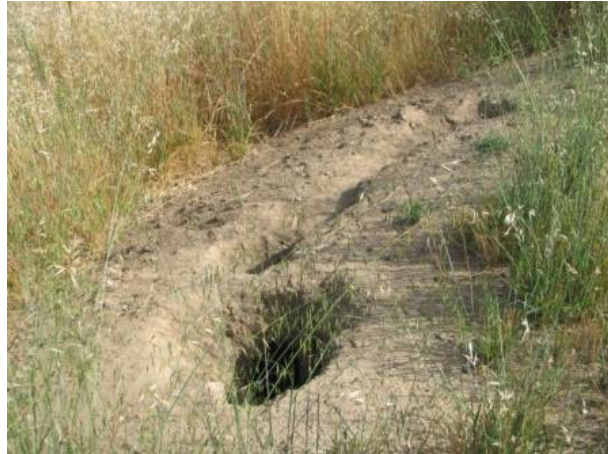
rduffey_s_20100609_033.jpg

Levee Mile Report Line	4
Start Levee Mile	3.08
End Levee Mile	3.08
Location	Land Side
Category	Earthen Levee
Item	Animal Control

View of large rodent holes along the landside of the levee.
